Replacement Strategy for Cast Iron Pipes in Western Australia

Ruicong Wei

CEED Client: Water Corporation

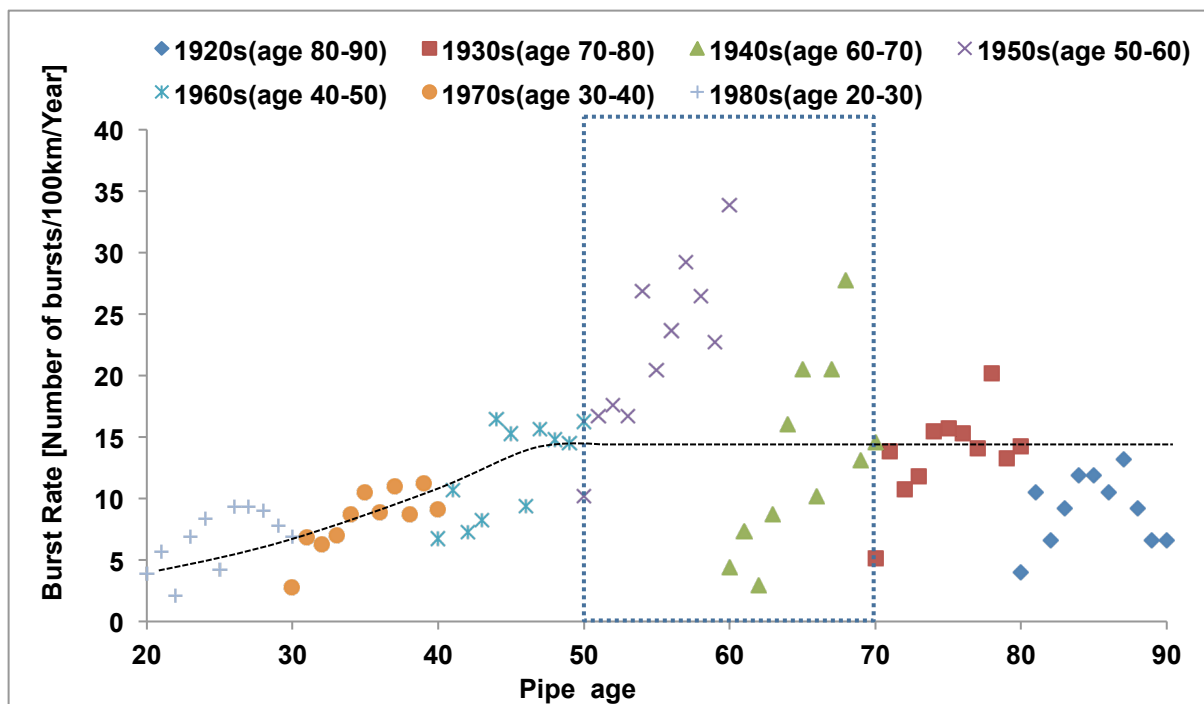
Figure 1 Summary of average pipe burst rate versus pipe age (data collected 2000-2010)

Figure 1 summarizes the average burst rate (expressed at number of bursts per 100 km of pipeline per year) vs. the installation time. If we exclude the CI pipe data installed in 1940s and 1950s as this group is an anomaly, which will be explained later, it is clear that the

average burst rate increases for pipes during initial 50 years of installation, and settles at a relatively stable rate of around 15 bursts per 100 km per year afterwards. If this level of average burst rate is acceptable, then a large-scale replacement of CI pipes installed between 1920-1930s and 1960-1980s is not warranted. Instead we should only replace particular pipe sections with repetitive bursts, most likely resulting from either operational or environmental specifics. From the data contained in the dashed box, it can be seen that pipes installed in 1940s and 1950s display unusually high burst rates, even when compared with much older pipes. Our experimental investigation revealed that the CI pipes installed in the 1950s have an average hardness of around 30% lower than the CI pipes in all other installation years (see Figure 5). This suggests that the unusually high historical burst rates of CI pipes installed in 1940s and 1950s are mainly due to the intrinsic lower strength of the pipes. This finding suggests that we should focus future large-scale replacement programs on the CI pipes installed in 1940s and 1950s.

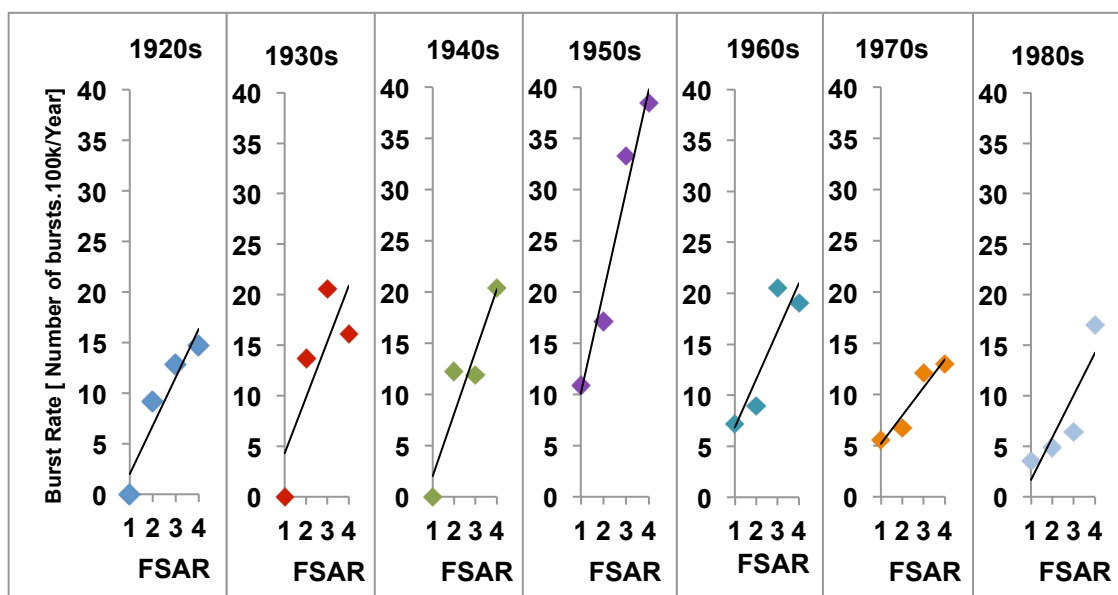
Figure 2 Average pipe burst rate versus ferrous soil aggressiveness rating (FSAR)

The effects of environmental factors such as the soil aggressiveness and depth to ground water were also studied. Correlations between CI pipes external corrosion rate and specific soil properties were investigated previously. (Seica et al., 2002; Doyle, 2000) Since different locations have different specific soil properties, and previous results have limited applicability, as a result of that, WC developed a ferrous soil aggressiveness rating (FSAR) based on WA soil environment and it is defined as a measure that takes into account salinity, pH, and waterlogging. The soil aggressiveness is increasing with FSAR. Figure 2 shows the effect of soil aggressiveness on the burst rate of CI pipes. As expected, a higher burst rate was observed for all pipes in more aggressive soils. In particular, the performance of pipes installed in the 1940s and 1950s are very poor in aggressive soils. This observation re-iterates the need to make the replacement of CI pipes installed in 1940s and 1950s as a priority for large-scale replacement programs, especially when they are buried in aggressive soil. Ground water will affect the soil wetness and salinity, thus it has potential to affect the pipe burst rate. This study examined the effect of depth to ground water. Figure 3 shows the effect of distance between the CI pipes and depth to ground water. It can be seen that the closer the pipe is to the ground water, the higher the burst rate is, within the distance of 0-6 m. In general, the

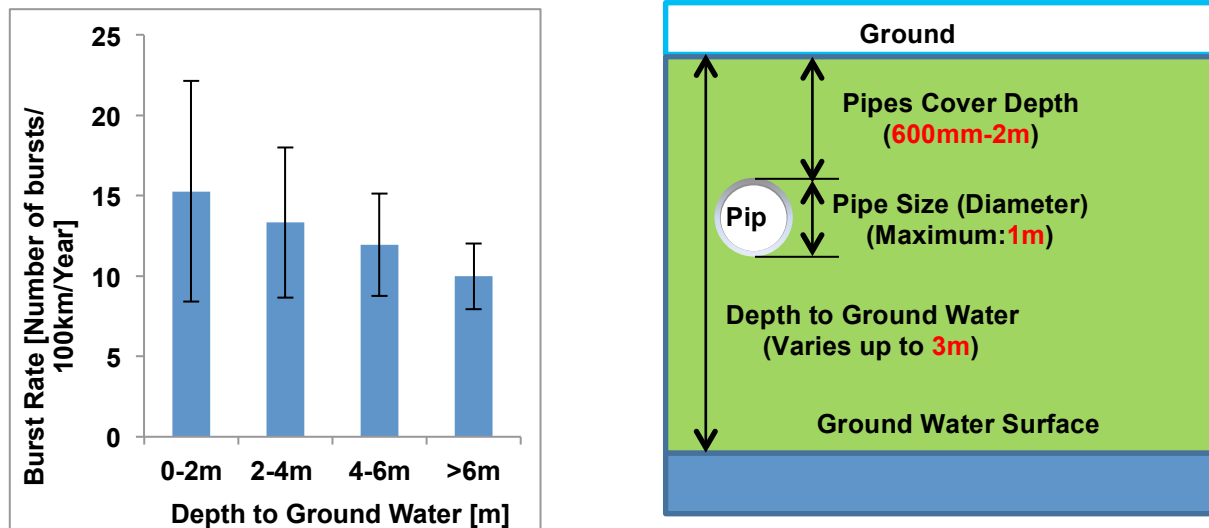
effect of depth to ground water is less significant than manufacturing batch, pipe age and soil aggressiveness. This study has also revealed the significant effect of operation pressure on the burst rate as shown in the Figure 4. This figure shows that pipes which are operated at higher water pressure on average for a long time will have higher risk of bursts.

Figure 3 Average pipe burst rate versus depth to ground water

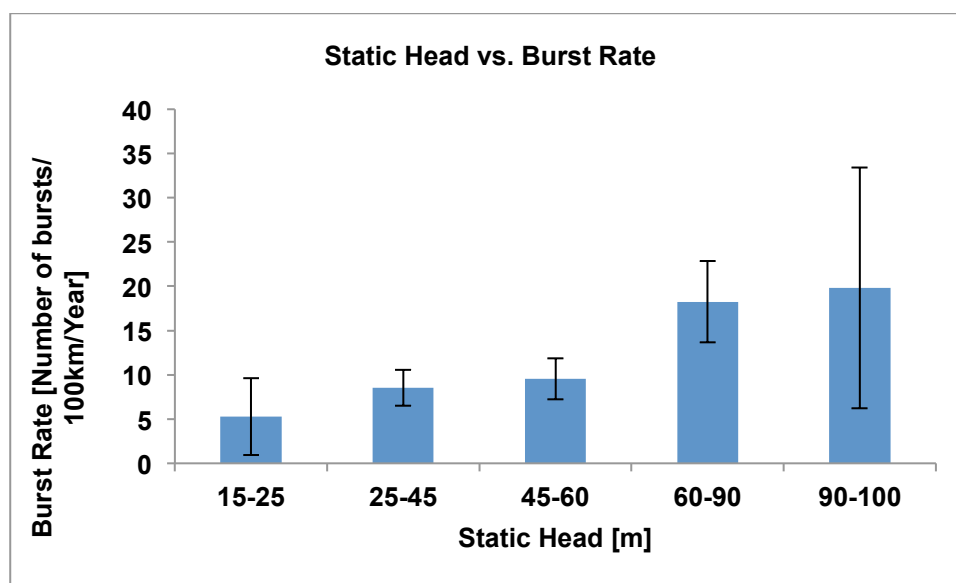
Figure 4 Average pipe burst rate versus operating pressure

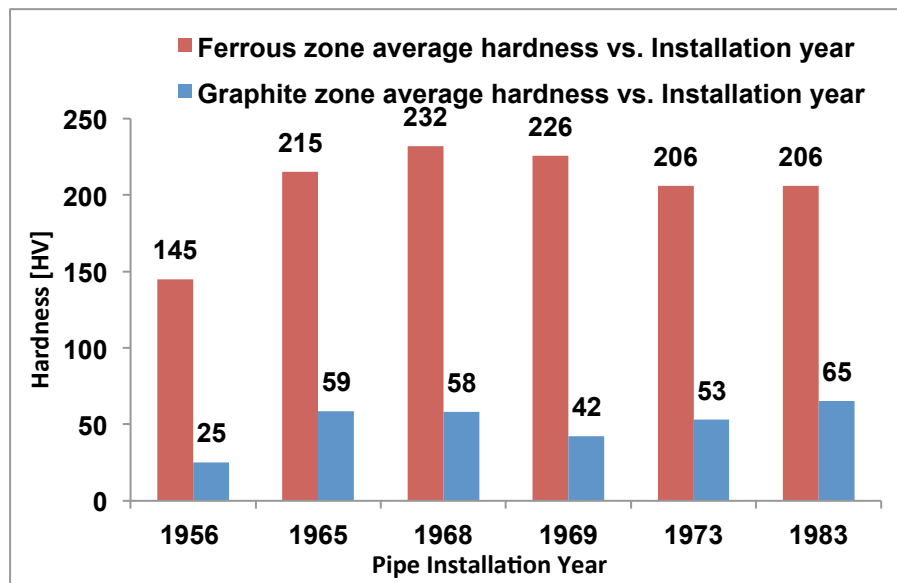
Figure 5 shows that the pipes manufactured in the 1950s (example 1956) has an initial hardness well below the other years and has had the largest reduction in hardness of 83% compared to others. This result is in consistent with statistical analysis result as discussed above.

Figure 5 Average pipe hardness versus pipe installation year

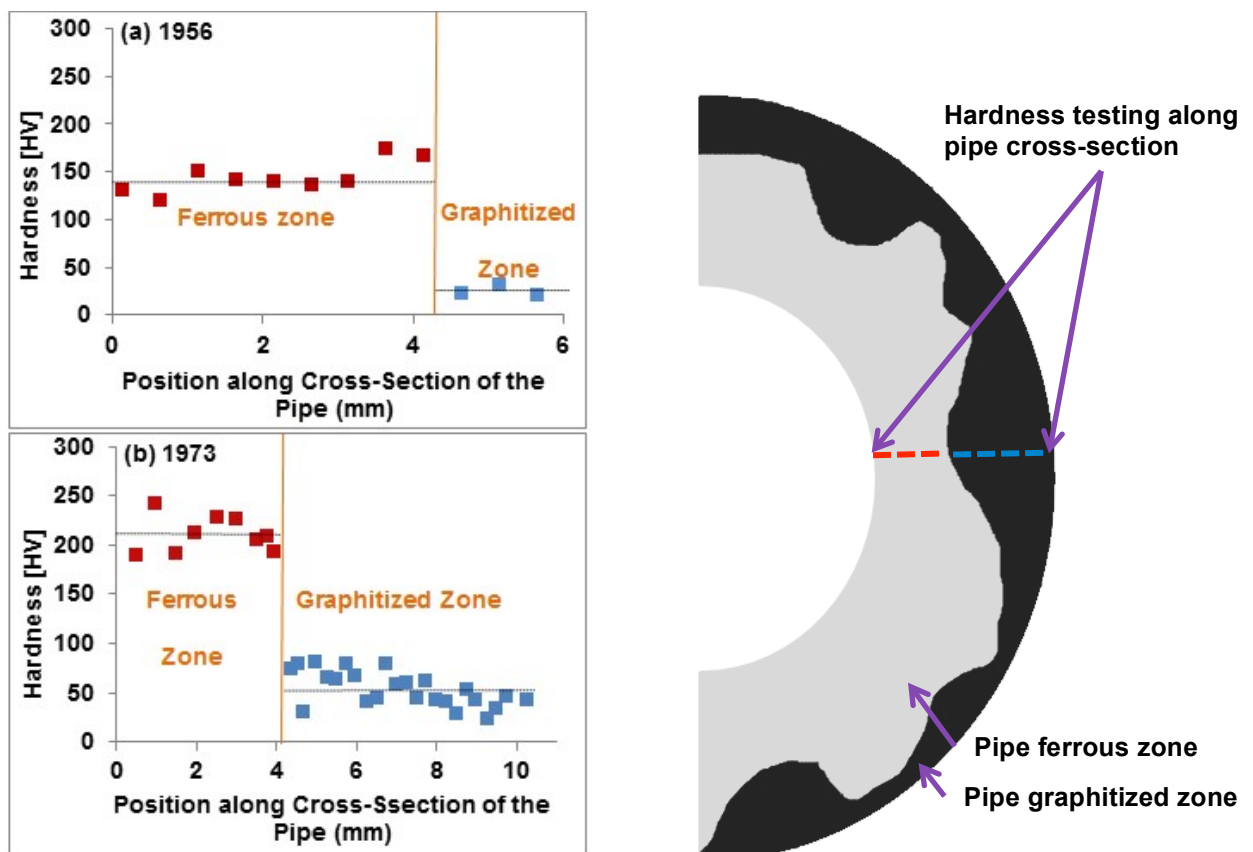
Figure 6 Comparison of hardness step change for pipes installed in different years

From Figure 6, it can be seen that instead of a transition zone, a definite step change exists between the ferrous and graphitized zones. On average, the hardness drops by 75% and occurs as a “step change”.
