# Investigation of Rubber Ring Seal Failures of Water Mains

CEED Client: Water Corporation

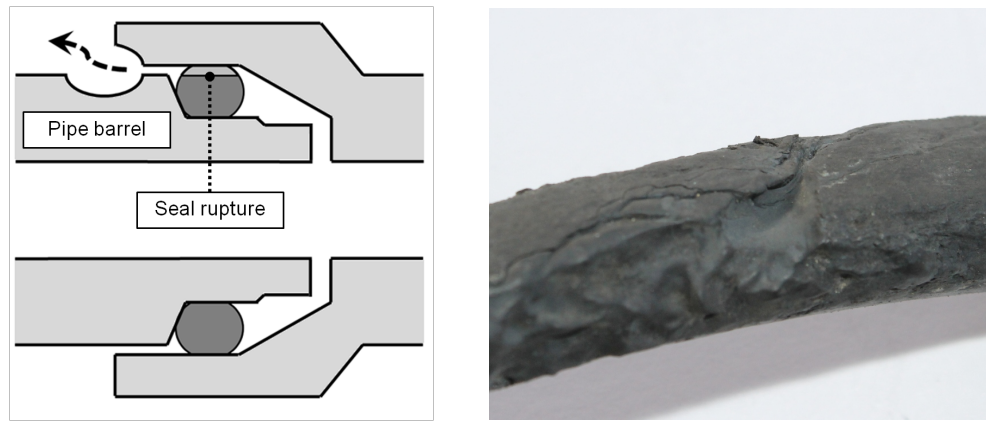
Figure 1 illustrates the characteristic rubber seal failure mode. A seal failure is identified externally by a localised eroded section of pipe barrel adjacent to a leaking joint. Upon disassembly of the joint, a ruptured or dislodged rubber seal is observed. These observations suggest the pipe failure is triggered by a seal allowing water to escape from the water main at high speed. This erodes the external pipe barrel nearby.

**Figure 1** (a) Water jet eroding pipe barrel following seal rupture  
(b) Ruptured seal

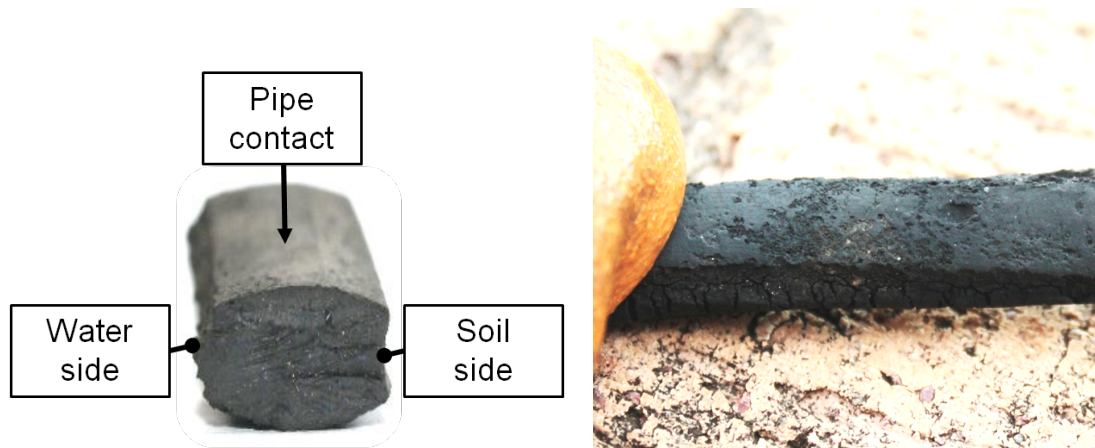
Seal material loss is observed exclusively on the surface of the rubber and the extent of material loss varies with location on the rubber surface. On non-failed seals, the greatest material loss is observed on the surfaces exposed to the soil or water sides (Figure 2a). Material loss is almost zero at the pipe-rubber contact surfaces; however upon close inspection, pitting is observed in some localised regions along the seal circumference. Cracking is also observed primarily on the exposed surfaces, indicating that the mechanical properties are weakest at the exposed surfaces and are not uniformly distributed inside the rubber volume. Considering both material loss and mechanical property changes occur in the same regions, the underlying mechanisms could be linked.

The predominant failure mode observed in the rubber seals is rupture, occurring in at least 79% of collected sample sets. Since the mechanical properties are generally weaker at the exposed surfaces, rupture due to surface defects seems more likely than internal defects. However, a brittle surface is not necessary to cause a rupture. Many seals ruptured but did not show clear signs of cracking. Another possibility is the expansion of pits at the pipe-rubber contact, forming a path to allow water escape (Figure 2b). Both these explanations fall under the proposed root cause of connectivity along the pipe-seal contact allowing water to leak out. The channel is then expanded into a larger hole due to post failure material loss.

**Figure 2** (a) Cross-section of a deteriorated seal  
(b) Localised pitting region on non-ruptured seal surface

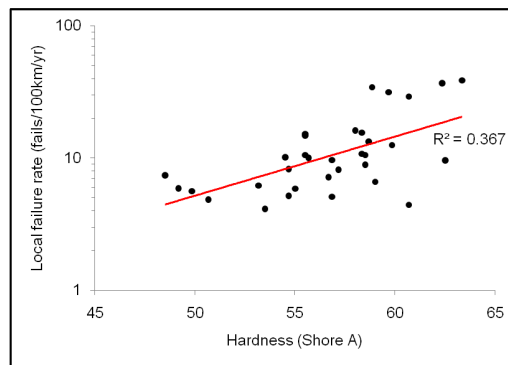
The relationship between the condition assessment parameters measured and local failure rates are summarised in Table 1. The strongest and most reliable condition assessment parameter measured is surface hardness. A higher surface hardness is associated with a higher failure rate (Figure 3a). This is consistent with the identified failure mode, since a brittle surface is more likely to develop surface cracks and allow water to escape. More material loss is also associated with a higher failure rate; however the accuracy of the current sample pool size is not regarded as high enough to be applied. This inaccuracy is due to filtering, density differences among seals and non-uniform thicknesses. Permanent deformation increased predictably with age; however when taking into account hardness, this parameter did not have any statistical relationship with failure rates.

**Figure 3 Relationship surface hardness and local failure rates**

1. Obtain condition assessment data from the field
2. Obtain local failure rates using Figure 3a, accounting for bias and lagging historical data
3. Obtain the minimum cost function using the calculated failure rate
