# Investigation of Reinforced Concrete Water Main Joint Failures

CEED Client: Water Corporation

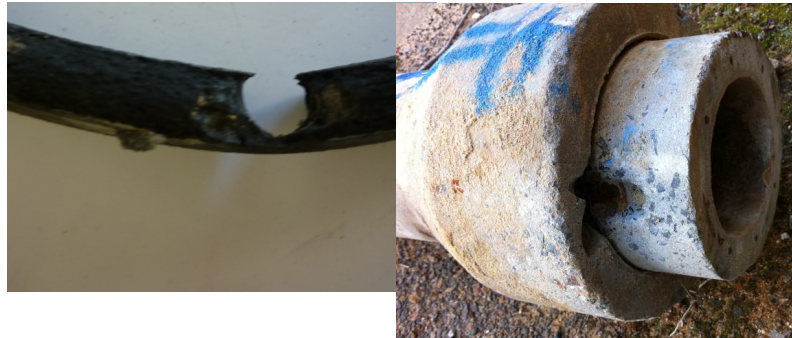
misdiagnosis of failures, joints become the most common failure location. This is supported by witness accounts from operators. Furthermore, the 44 samples of RC pipe collected in the previous study had an average condition rating of 1.2 out of 5, indicating that the concrete itself was in very good condition with less than 35% of its service life consumed (Pratt, 2011). It is then postulated that the majority of RC pipe failures are not caused by the deterioration of the concrete but due to the rubber O-ring within the joint failing in its sealing capacity, an example of which is displayed in Figure 1 (a). This allows a high velocity jet of water to escape which rapidly erodes the surrounding concrete and produces a characteristic localised hole pictured in Figure 1 (b).

**Figure 1 (a) Failed rubber ring and (b) characteristic RC pipe failure**

The failure of the rubber O-rings in their sealing capacity are considered the root cause of the majority of joint failures. The possible reasons for the loss of sealing capacity of an O-ring include loss of elasticity, loss of profile (by material removal or permanent deformation) and rupture. This project conducts the investigation in two parts: (1) statistical analysis of the archive data and (2) experimental investigation to assess the change in physical properties over service time.

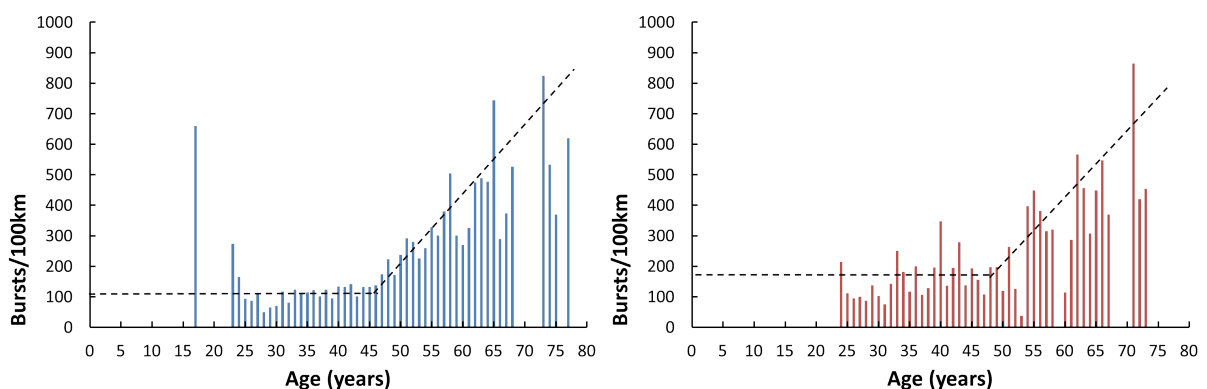
Figure 2 Burst rate against age for (a) DN100 and (b) DN150 RC pipe

The failure rate appears to remain fairly constant for both graphs until around 45 years when a rapid increase is observed. This could suggest that the effect of ageing becomes significant only after 45 years, at which time the failure rate increases due to the decreased ability of the rubber O-ring to maintain an adequate seal. It is important to note that the observation period for this data only started in 2000 and so records for pipes which have failed prior to 2000 are

likely to be incomplete. There appears to be an anomalous peak in burst rate at the age of 17 years for the DN100 pipe but further inspection of the data revealed that only 151 m of pipe was installed in that year (the average length installed each year was over 28 km).

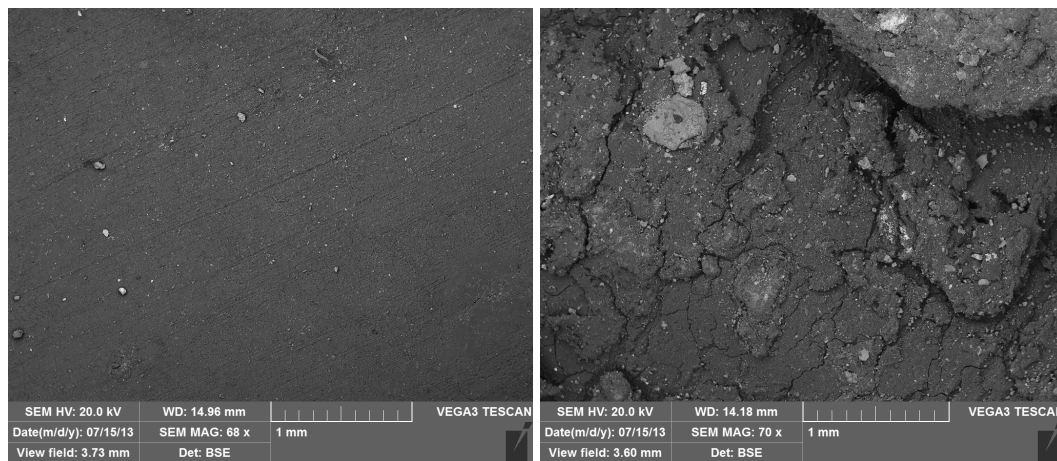
Figure 3 SEM image of surface of (a) new rubber and (b) aged rubber

The new rubber is smooth while the aged rubber is rough with random ridges and valleys. This could be indicative of chemical attack however more testing is required to confirm this.

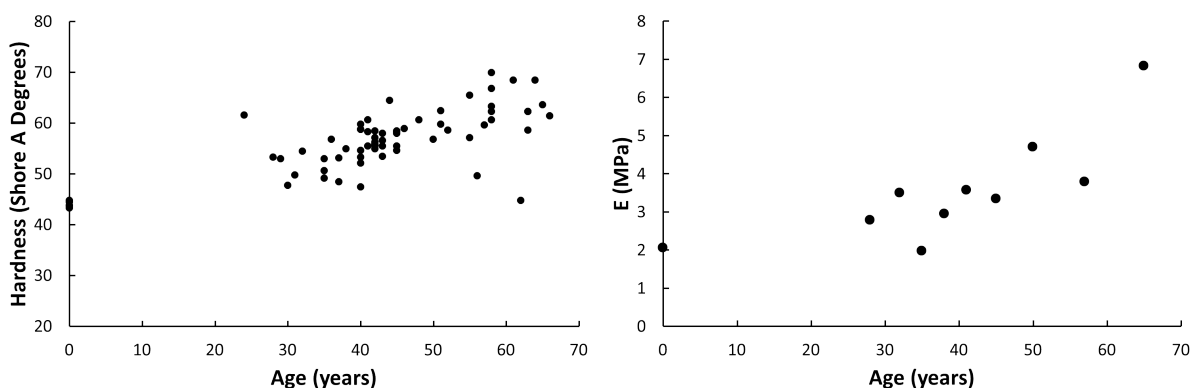
Figure 4 (a) Hardness against age and (b) young's modulus against age

There is a general upwards trend of rubber hardness as age increases, this supports the argument that the rubber O-rings are losing their elasticity. The youngest sample collected is 24 years old and although samples in a new condition were sourced from the supplier there is no data for rubber rings between these two ages. As a result it is not known how the trend

changes in this time, it is possible that there is no change in hardness with age until a critical point or there may be a gradual increase between 0 and 24 years. The young's modulus of the rubber is also seen to follow this upwards trend indicating a stiffening of the rubber, and thus a loss of elasticity, over time.

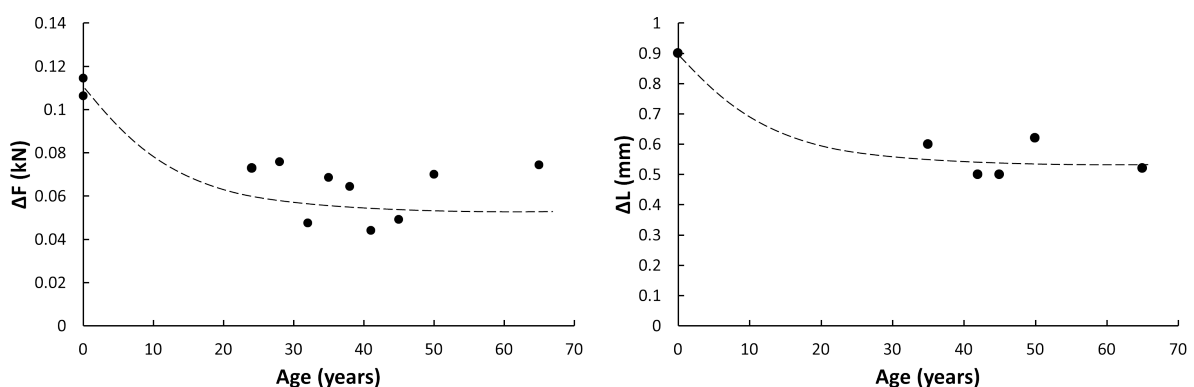
Figure 6 (a) Relaxation behavior and (b) recovery behavior

There is a general downward trend for both graphs which then appears to plateau. Stress relaxation in natural rubber occurs through viscoelastic flow within the material or through scission of the polymer chains or crosslinks (Robinson & Vodden, 1955). The reason for a decreased level of stress relaxation for older samples is that a degree of viscoelastic flow will have already occurred so that under a compression test there is a limit to the amount of further chain-on-chain slippage and untangling of chains. This means less stress can be relieved

through these mechanisms. Similarly less deformation can be recovered as the rubber ages as more crosslinks undergo chain scission leaving fewer strained crosslinks that have the ability of applying a restoring force.

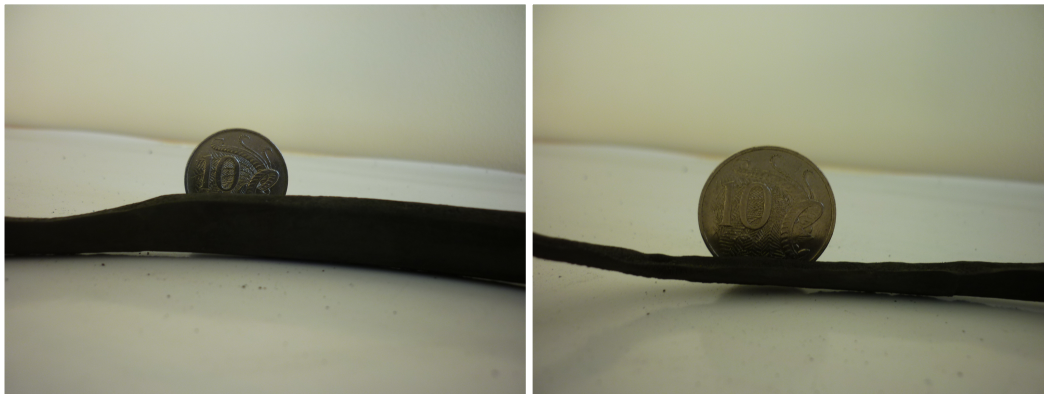
Evidence suggests a definite change to the behavior of natural rubber as it ages. The rubber O-rings are seen to harden over time with a gradual upwards trend. This hardening of rubber is indicative of the gradual loss of elasticity the material experiences as time progresses. The loss of elasticity is one suggested cause for an increase in failure rate which could be the reason for the sudden increase in historic failure data observed between 45 and 50 years of pipe age. The other failure modes suggested by this study are a loss of profile and rupture of the rubber. These two failure modes require further analysis so that the most significant of the three failure modes can be identified. Figure 7 shows the cross-section of a rubber that has undergone significant material removal. Loss of profile, specifically material removal, can be a result of the previously described water jet eroding the rubber as it evacuates the pipe. This makes it difficult to classify whether loss of profile is the cause of a pipe burst event or a subsequent consequence of a burst caused by another failure mode. It is suggested that any future work should be focused on the loss of profile through material removal.

Figure 7 (a) Rubber O-ring with little to no material removal and (b) rubber O-ring with severe material removal
