# Optimisation of Rolling Stock Wheel Machining

Brooke Shaw

John McArthur  
CEED Client

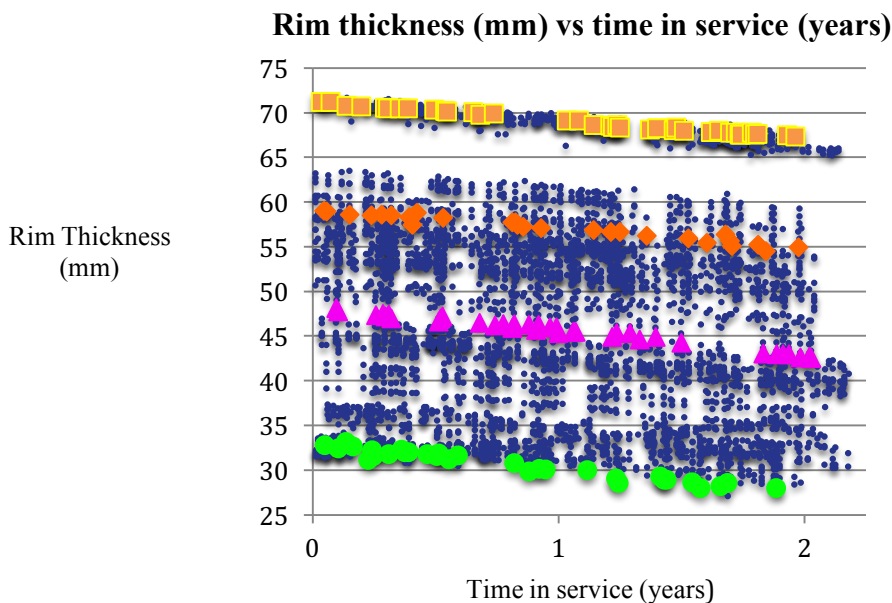
Figure 3. Scatter plot demonstrating rim wear

A strong negative linear relationship was found between rim thickness (mm) and time in service (years). A scatter plot of all the rim thickness data over time is shown in Figure 3. The data for several individual wheels are highlighted to demonstrate the negative linear correlation between rim thickness and years in service.

Each wheel in the sample starts with a discrete rim thickness that decreases linearly with time in service. The linear regression found a wear rate of -2.39 mm/year, the r-squared value ( $R^2$ )

found was high (0.98) showing low variability in the data. No significant difference between the wear rate was found based on vehicle side (left/right) and axle position (1-8).

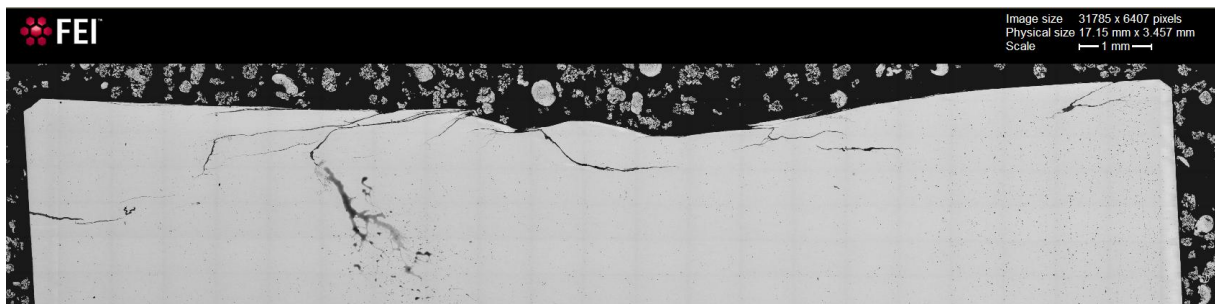
Figure 4: Image of Wheel Tread

For microscopy analysis, the sample was mounted such that the damaged tread surface was perpendicular to the microscope. This allowed the microscope to capture the depth of damage into the wheel tread. Cracking can be seen propagating into the wheel rim with a maximum cracking distance of 1.7 mm from the surface of the tread in sample 1 (Figure 4). More electron microscopy analysis must be completed to determine the depth of damage for other defects.

The wear rates and modes were examined for a sample of 142 wheels with two years of data. This sample size could be increased to more accurately reflect the wear rates of the population. The electron microscopy analysis found that the maximum damage depth was 1.7 mm for a moderately damaged wheel with spalling. In order to determine the maximum depth of damage for wheels with spalling more samples should be analysed using SEM.
