Accelerated Corrosion on Roof Purlins

Lee Tin Lim
CEED Client: Water Corporation

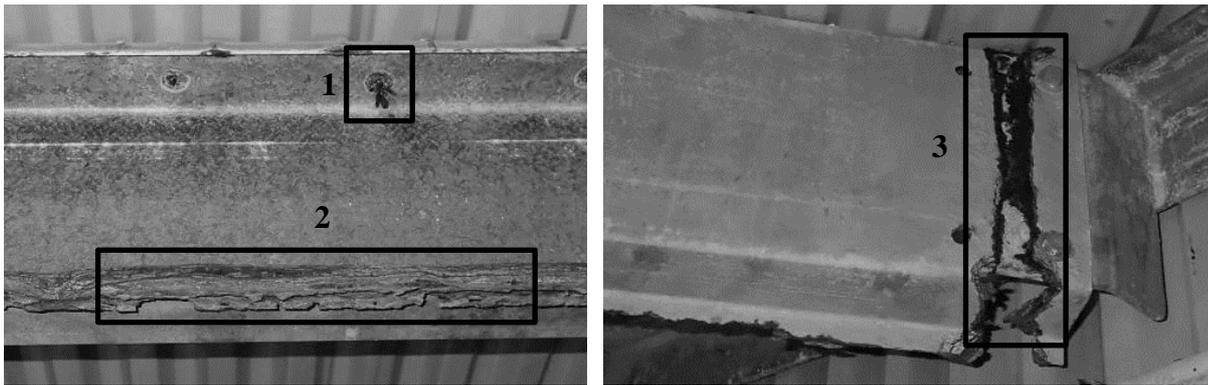
Tank A has been in operation for 13 years, with significant corrosion present. The extent of the corrosion can be seen in Figure 1. With deterioration occurring around the bottom edges and connection points of the purlins, as well as the tek screws (screws that hold the purlins in place).

Figure 1 Tank A internal steel roof photos taken from an inspection report in 2020, showing an advanced state of corrosion on the purlins tek screws (1), bottom edges (2) and connection points (3).

The increased humidity inside the tank due to inadequate ventilation in combination with the slightly higher free chlorine residual concentration creates an unfavourable environment. This environment is a likely cause of the accelerated rate of corrosion that the steel purlins are currently experiencing.

The most obvious and effective solution to reducing Tank A's rate of corrosion, is to increase the size of ventilation when a roof replacement is required. To effectively account for inflows and humidity the new ventilation system would need to double in size.

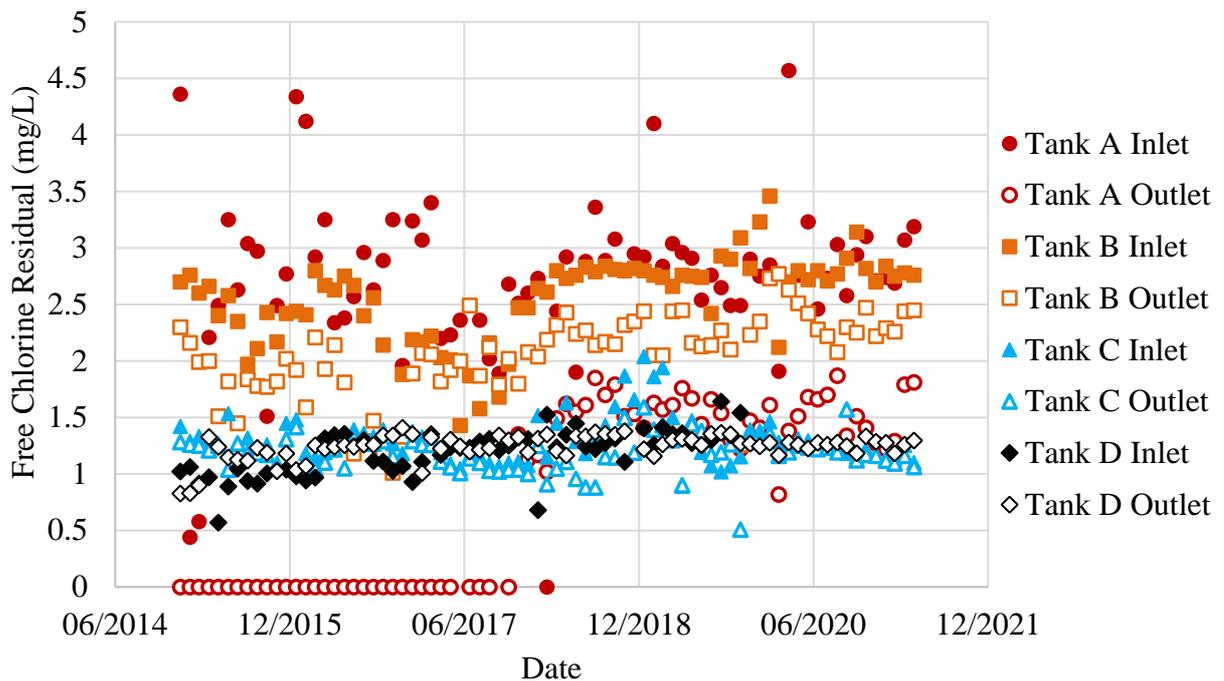
The inlet and outlet water free chlorine residual were assessed for 4 tanks including Tank A, seen in Figure 2. The solid filled symbols represent the inlet concentration while the outlined symbols represent the outlet concentration in each tank. Tank A and Tank B inlets have the highest free chlorine residuals. This may be a result from both tanks being located in close proximity to the water treatment plant (where the water is dosed with chlorine). As chlorine decays with time, the less distance travelled the higher the concentration should be. The tanks used for comparison vary in multiple ways. Tank B was used due to it having the same approximate distance to the water treatment plant as Tank A. Tank C and D are located in the same approximate region with Tank C being a secondary chlorination site and Tank D is a primary chlorination site, the same as Tank A.

Tank A outlet points from the end of 2014 to the start of 2018 have a zero chlorine concentration. This may be a result of the analyser being broken or turned off but have not been taken out due to uncertainty

Figure 2 Free chlorine residual concentration for Tanks A-D for both the inlet and outlet.

From further discussions it was concluded that best representation of the free chlorine concentration in the tank is given by the tank outlet. From Figure 2, Tank B’s outlet concentration is high. There are many reasons for this difference including the different climate and distance to distribution tanks. As this isn’t the tank at interest these possible outcomes aren’t further explored. Tank A’s outlet concentration is slightly above those of the other same geographical location tanks (C and D).

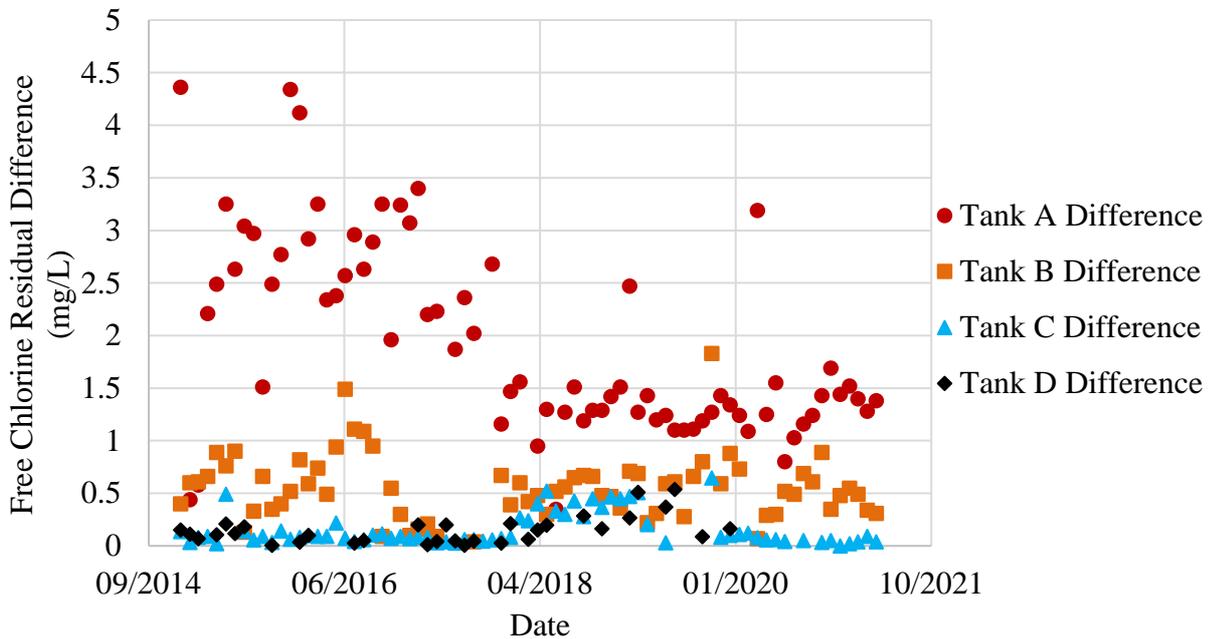
Figure 3 Free chlorine residual difference for Tanks A-D.

Tank A chlorine points from the end of 2014 to the start of 2018, are significantly higher than the later half of the trend due to the outlet zero value and should be noted when looking at trends. Taking this into account Tank A still has a significantly higher difference, with its average concentration lying in the 1-1.5 mg/L range. Tank B has a slightly high concentration averaging from 0.4-1 mg/L. While Tanks C and D have the same approximate difference of about 0.1-0.2 mg/L.

There are many possible reasons for the large difference in Tank A’s free chlorine residual concentration. The first is the distance from the chlorine analyser to the tank. For example, the inlet analyser may be located only a meter or kilometres away from the actual tank. As chlorine decay is influenced by time, the longer it has to travel the more decay will occur. The difference in free chlorine concentration was deemed to be too difficult to further investigate given the projects time constraint.
