Design and Pendulum Testing of a Frangible Guardrail Post for use in End Terminals

Main Roads Western Australia (MRWA)

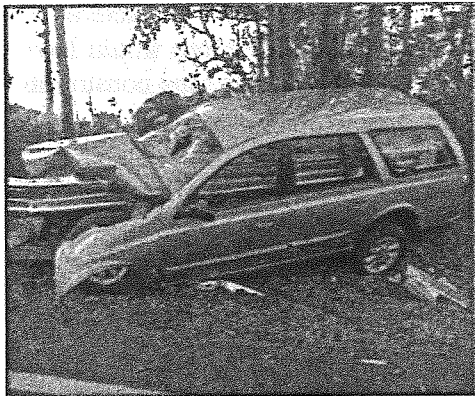
Fig. 1 – Guardrail spearing incident

The unprotected ends of guardrails are especially hazardous in “end-on” collisions, where the vehicle impacts the barrier while travelling in a direction parallel to the road. The guardrail can often act as a spear and penetrate the occupant compartment of the vehicle (Fig. 1).

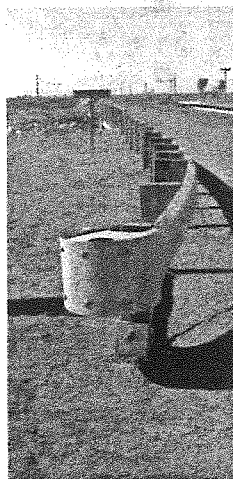
Fig. 2 – WAMELT End terminal

To overcome this problem, the end sections of the guardrails are modified in certain ways. These modifications are known as “end terminals” or “end treatments” (see Fig. 2), and are crash-tested to verify their performance. (Woon, 2003)

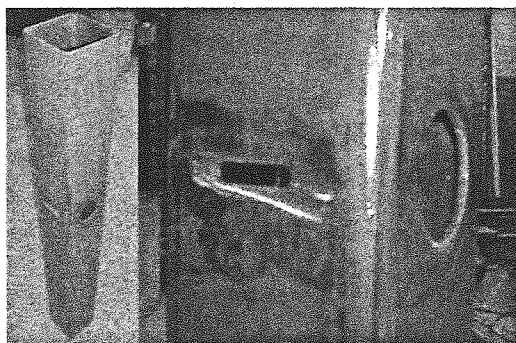
Fig. 5 – BAW Post steel replacement design

From the data available, a number of prototypes were designed for both post types. The designs were to be based on standard steel sections for simplicity and economy. C-channel and I-beam sections had already been used in current proprietary designs. Therefore a rectangular hollow section was chosen, which also has the advantage of being torsionally rigid. Slots were cut into the sides of each post to reduce the moment of inertia. The BAW post needed a large cable hole to suit the current end terminal design (See Fig. 4 & 5).

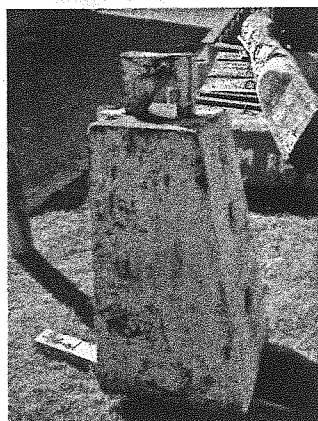
Fig. 6 – 1 tonne impactor

Pendulum testing was the most practical and useful method for testing the new posts, because the energy of the impactor could be easily controlled based its initial height. The option of setting up a local testing rig was investigated. A suitable 1-tonne impactor was sourced from Curtin University (see Fig. 6). An investigation was conducted into the feasibility of setting up a local test-rig inside a MRWA building in Welshpool (See Fig. 7).

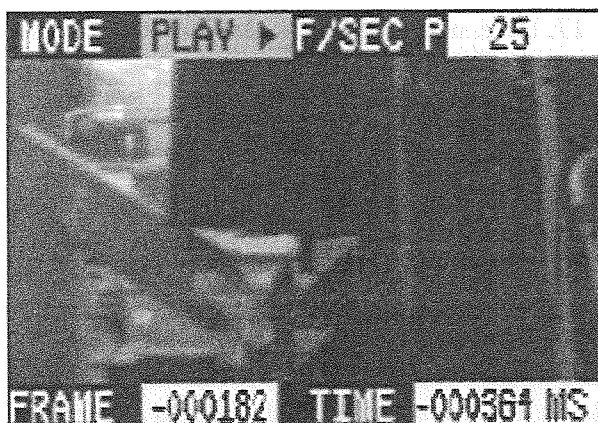
Fig. 13 – High speed timber post impact photo

From the photographs (Figs. 13-17), the different failure modes of the posts can be observed. The timber posts always failed in a brittle manner, as shown in Figs. 13 and 15. This behaviour is common to all timber posts due to the nature of the material.

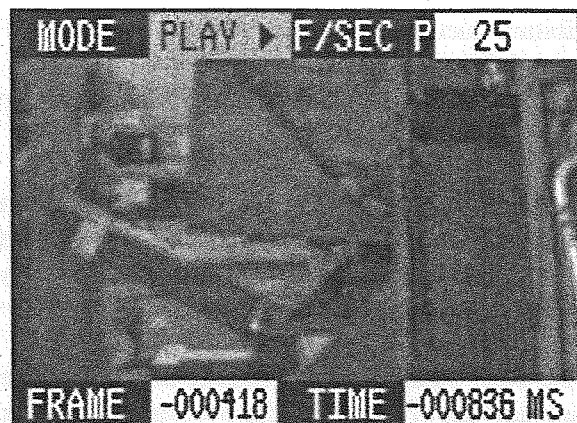
Fig. 14 – High speed steel post impact photo
