Development of Method to Assess the Integrity of Metal Streetlight Poles

CEED Client: West Coast Energy Pty Ltd

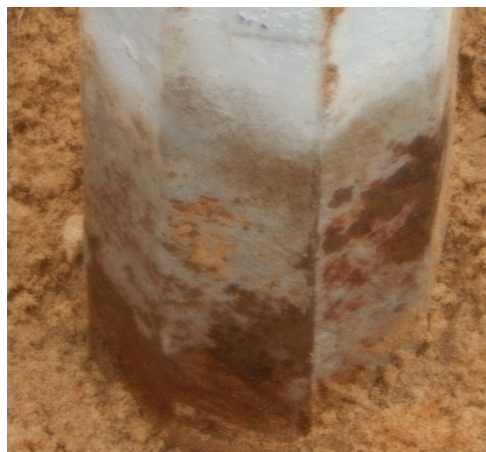
Figure 1 Example of S5 pole condition after excavation and cleaning

It was common to see evidence of corrosion even after past treatments, indicating that the treatments may not be having the desired effect. The most likely reason for this is that the

surface was not sufficiently cleaned for the past treatment or the spray was not allowed enough time to dry. Further investigation into the exact causes could be beneficial for WCE and client's if this treatment plan is to remain.

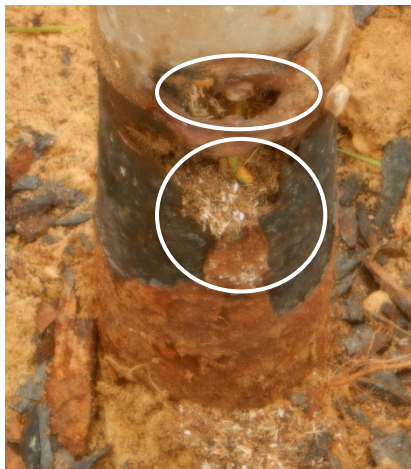
All severe S1 condition poles showed highly localised corrosion that at certain points was so far progressed that there was a hole or cracks equivalent to 10% or greater of the pole circumference. Figure 2 below shows an example of this level of severity with the holes circled (they are hard to see since the inside of the pole has filled with dirt).

Figure 2 Example of S1 pole condition after excavation

This pole was noticeably worse on arrival to the site – it was possible to see the corrosion “bulging” around the pole's circumference due to the build up over time. Figure 2 was taken after this excess had been removed, as initially the hole was not visible. Most S1 cases had the same feature of a bulging ring of corrosion that was visible before any digging took place.
