Deterioration of Asbestos-Cement Pipes

Esther Loh
CEED Client: Water Corporation

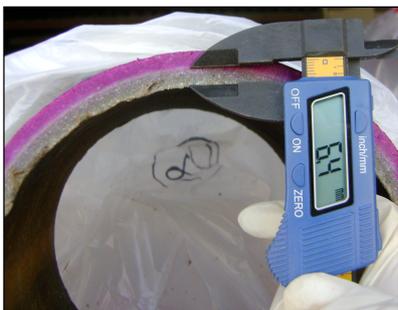
Figure 1: phenolphthalein testing of AC pipe.

The methodology for AC pipe testing was restricted by strict safety guidelines. The experimentation of this project consisted of three parts; visual examination, mechanical tests and microstructure analysis of AC pipes. Visual examination was conducted using 0.01% phenolphthalein to moisten a cut surface of the sample. Sound material is indicated by the violet colour and leached material is colourless, as shown in figure 1.

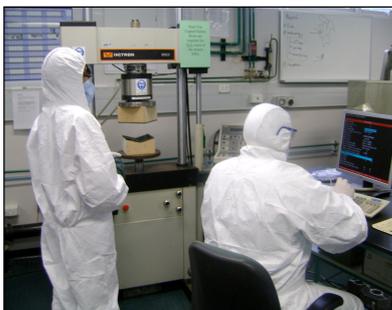
Figure 2: Crushing test using the Instron machine with V-blocks.

The mechanical properties were examined through Vickers hardness, compressive and three point bending tests. Compressive test was conducted on an Instron 8501 machine with V-shaped testing blocks as shown in figure 2. The samples were cut by JPJ constructions according to the ratio of 1:1 of diameter to length. Three-point bending test was performed using pre-cut samples of 10x10x150mm rectangular strips. The support distance for the three-point bending was 75mm.

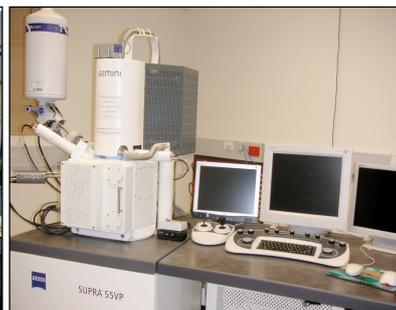
Figure 3: Zeiss 1555 SEM used for structural and EDS analysis.

The microstructure of the AC samples was examined by using a Zeiss 1555 (Figure 3) scanning electron microscope (SEM) which was equipped with an energy dispersive spectrometry (EDS) analyser for compositional analysis.
