Shear Capacity of Half-cap Scarf Splices of Timber Bridges

Lovell Chang

Department of Civil, Environmental and Mining Engineering
University of Western Australia

CEED Client: Main Roads Western Australia

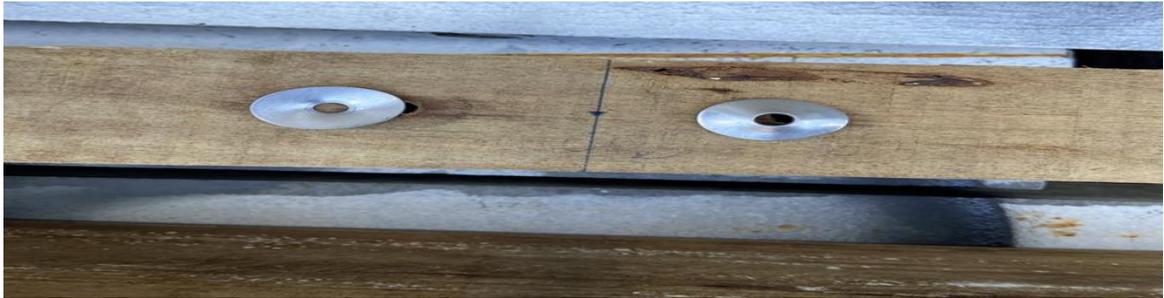
Figure 4 Bending of washers and indentation of the timber.

The load transferred to the joint had caused the bending of the washers, as shown in Figure 4. The washers compressed and indented into the timber at the vicinity of the bolt holes. Wood cracking sounds were heard during the test, which possibly corresponded to this indenting. However, eventually, the scarf joint failed through the shearing off of a nut from the

threaded rod, unexpectedly. Upon reviewing the component strength grades, it was found the nuts were made of Grade 4.6 steel, while the threaded rods were made of Grade 8.8 steel. Insufficient grip and insufficient strength of the nuts had caused this unexpected failure mode to occur, which will be rectified for the main test program (i.e. by using Grade 8.8. nuts).

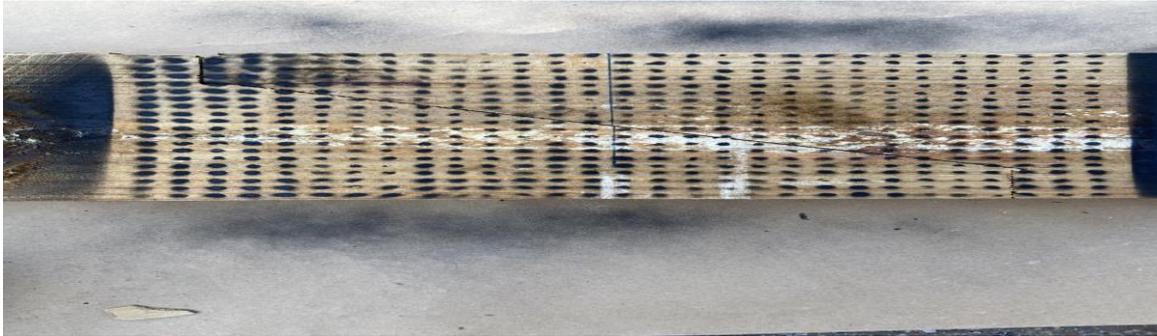
Figure 5 Speckles pattern with constant spacing to be used for DIC.
