Materials of Construction in a Solar Salt Environment

Lucas Brown

Tim Sercombe
Mechanical Engineering
The University of Western Australia

Vanessa Farquharson
CEED Client: Rio Tinto / Dampier Salt Limited

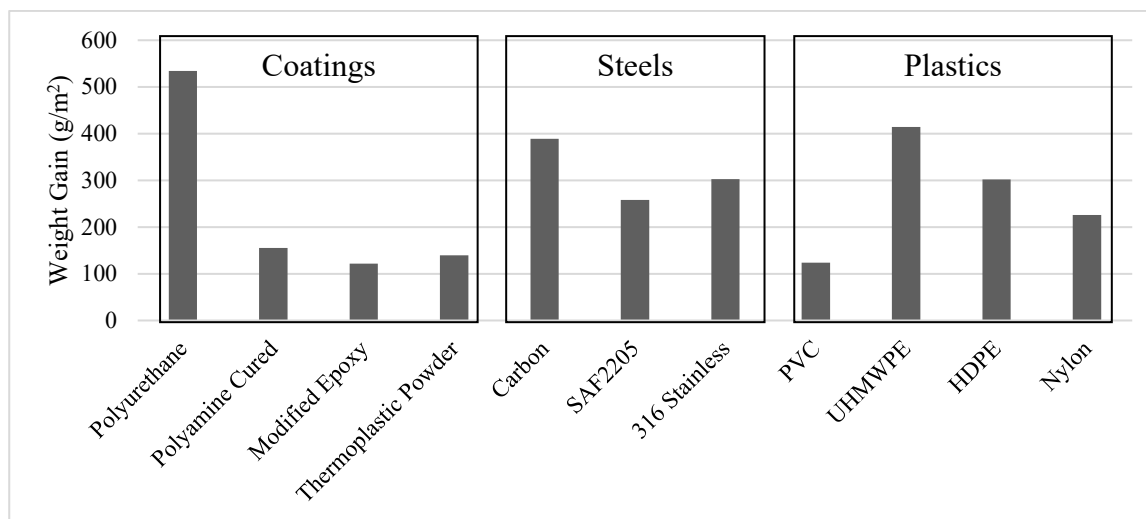
Figure 2 Screening Test Weight Gain per Surface Area

Coupons were weighed and recorded after every cycle. The total weight gain after 10 cycles is shown in Figure 2, with values standardized per square metre.

These values are also paired with visual inspection, as weight gain may also be attributed to water absorption, which is an issue associated with plastics such as HDPE, experienced on-site. PVC and the thermoplastic powder coating gained 124 and 139 g/m², respectively, combined with minor appearance changes and were hence given 4/5.

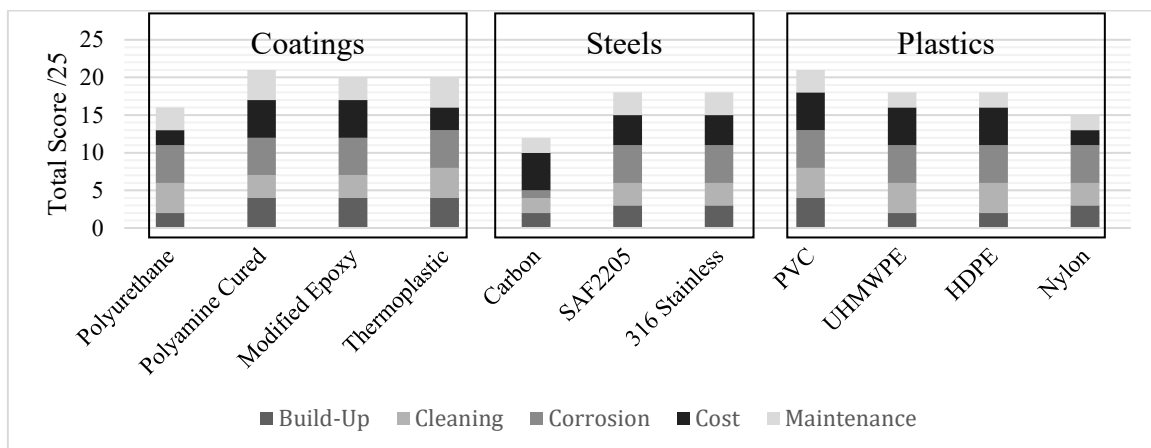
Figure 3 Screening Test Material Scores

As seen in Figure 3, the most desirable materials, based on the scoring mechanism proposed by these works, are PVC and modified polyamine cured coating, scoring 21/25, due to low-cost procurement, minimal build-up and ease of cleaning. Modified epoxy barrier (20/25) and thermoplastic powder coatings (20/25) both display strong performance in these harsh environments. Likewise, 316 stainless and SAF2205 were consistent in terms of their material performance, and hence, taken forward for on-site testing.
